# Technical Service Bulletin

### BULLETIN PA008-11

TCK257  
TCK257A  
TCKWP257  
TCKWP257A  
T257

### REAR CAM ALIGNMENT

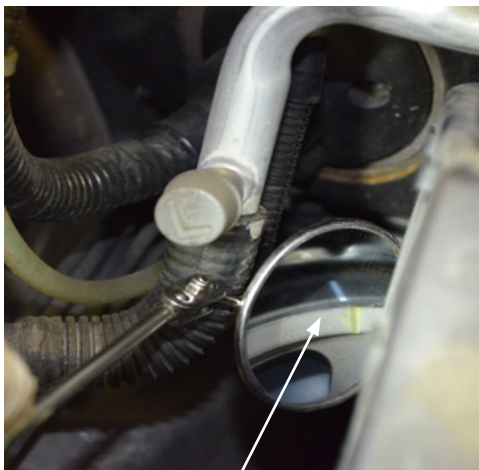
The most common cause found with immediate illumination of the MIL associated to cam sensor codes has been misalignment between the rear cam gear and timing belt. Illumination of the MIL will occur with the cam being one tooth advanced or retarded.

Rear Cam Alignment With Mirror For Verification Highly Recommended

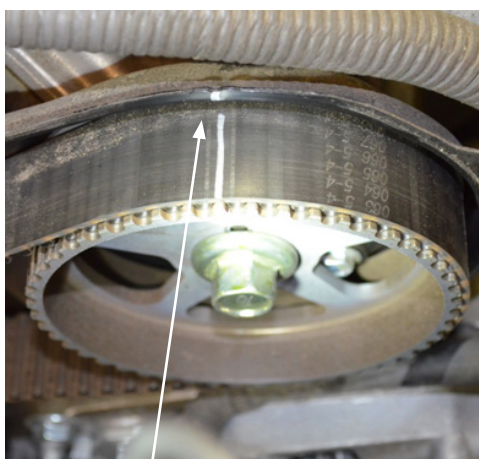
Front Cam Alignment

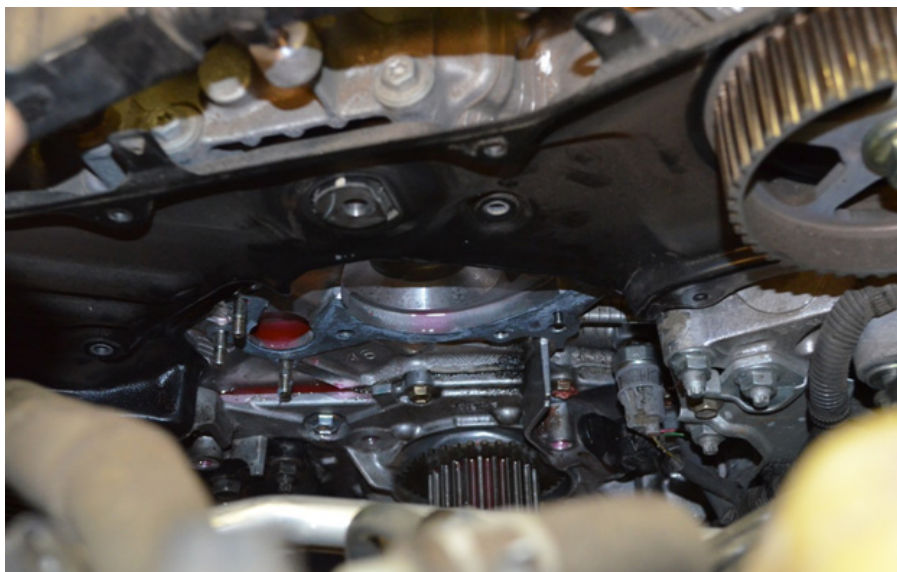
NOTE: Do not interchange or mix cam gear if they are removed – ensure they are kept in appropriate order. [right vs. left and front vs. rear]

Gates always recommends replacement of the water pump assembly combined with a complete flush of the cooling system when performing timing system maintenance. Removal of the upper rear cam gear cover is unnecessary in order to R&R the water pump unless cam seal renewal is also being performed.

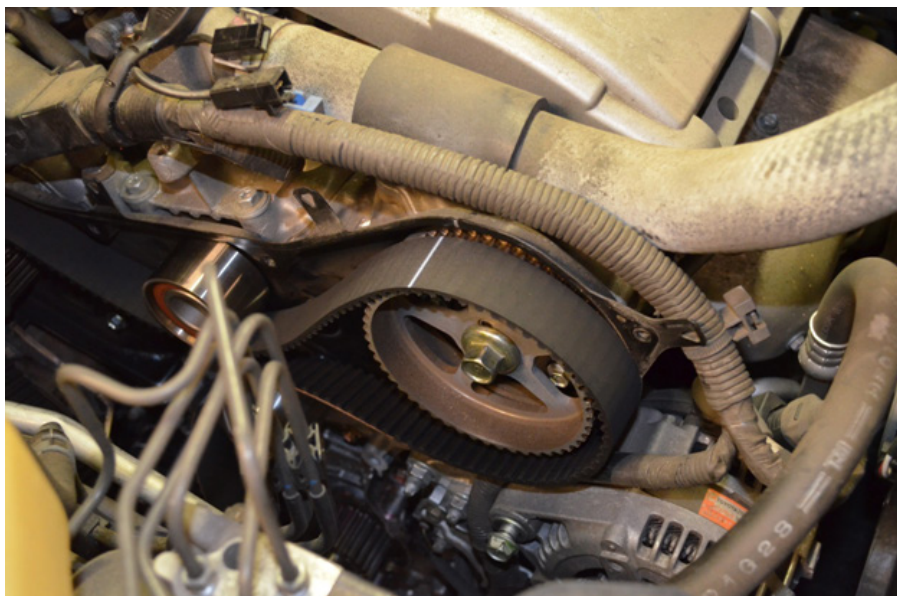
Cautions on related system components would include verification of the upper idler pulley operation. Due to the step design within the pulley, it is possible to secure this component at an improper angle. Ensure the idler pulley is operating within the same system plane and that the timing belt is tracking in the center of the bearing.
