# Technical Service Bulletin

### BULLETIN PA008-11

TCK257  
TCK257A  
TCKWP257  
TCKWP257A  
T257

### REAR CAM ALIGNMENT

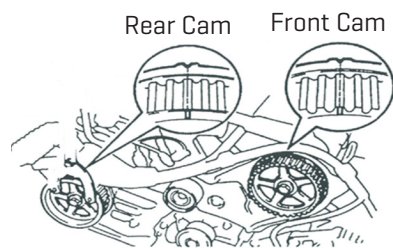
The most common cause found with immediate illumination of the MIL associated to cam sensor codes has been misalignment between the rear cam gear and timing belt. Illumination of the MIL will occur with the cam being one tooth advanced or retarded.
